## Product Change Notice (PCN)

**PCN Number:** PCN-0451152R-01

**Product(s) Affected:** PJ-038A, PJ-038B, PJ-038AH, PJ-038BH

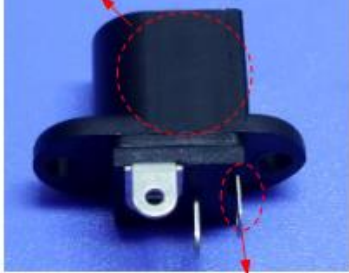
<p>Top</p>	<p>without injection mark</p>

<p>thickness of pin#2 is 0.2mm</p>	<p>with injection mark</p>

**Description of Change:** Thickness of pin 2 changed from 0.2mm to 0.25mm. Aesthetic changes as shown in below comparisons:

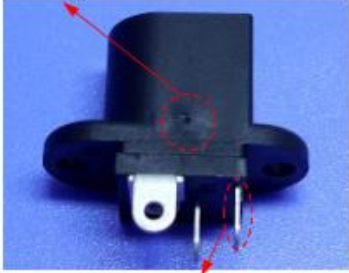
<p>thickness of pin#2 is 0.25mm</p>
<p>Bottom</p>	<p>rough surface with injection mark</p>

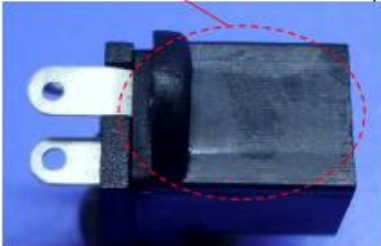
<p>A photograph of the same component as in the previous image. A red dashed circle highlights the surface of the tab, which appears smooth and uniform. A red arrow points from the text 'smooth surface' to this area.</p>
Left	<p>rough surface</p>

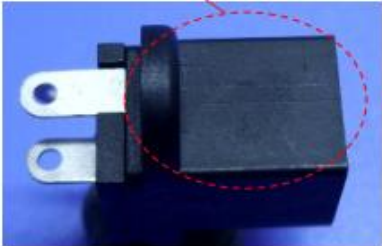
<p>A photograph of the component from a left-side perspective. A red dashed circle highlights the surface of the metal tab, which appears rough and textured. A red arrow points from the text 'rough surface' to this area.</p>	<p>smooth surface</p>

<p>A photograph of the component from a left-side perspective. A red dashed circle highlights the surface of the metal tab, which appears smooth and uniform. A red arrow points from the text 'smooth surface' to this area.</p>
